PROGRAM FOR IMPACT TESTING OF SPAR-SHELL FAN BLADES

TEST REPORT

GENERAL ELECTRIC COMPANY

NASA-Lewis Research Center
NAS3-20801

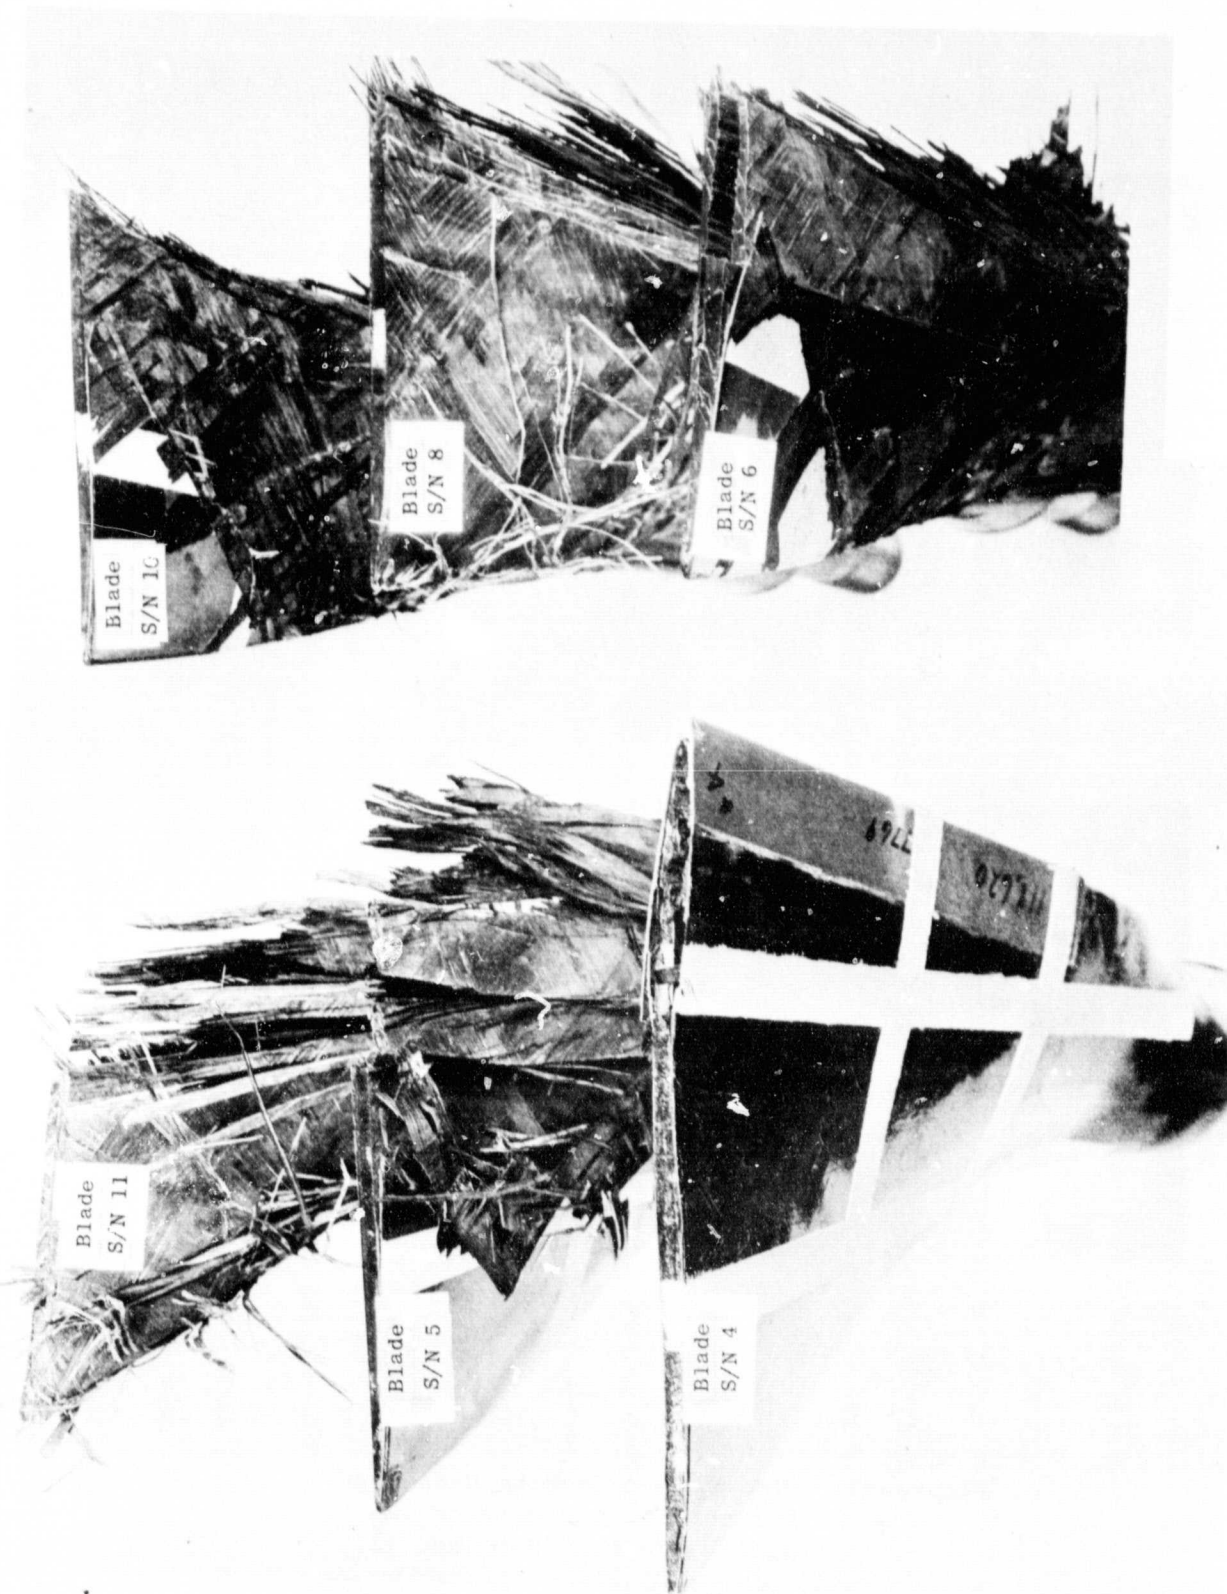
All of the four blades, tested with RTV birds, lost the stainless steel leading edge and suffered severe breakage and delamination of the airfoil. In these tests, the bird slice size ranged from 0.391 kg (13.8 oz) to 0.482 kg (17.0 oz). Test Numbers 1, 2, and 3 had the blade angle set at 33° at the 80% span impact location, while Test Number 4 had the blade angle set at 23°. Material loss varied from 0.463 kg (1.2 lb) to 0.703 kg (1.55 lb), generally in proportion to the slice weight. For the starling impact of Test Number 5, the blade angle was set at 33° at the 80% span impact location, and damage consisted of the loss of the leading edge protection plus fiber breakage and delamination. This damage differed only slightly from that on the other blades impacted by larger RTV bird slices. The airfoil material loss was 0.299 kg (0.66 lb) for this test.

Figure 45. QCSEE Fiber-Wound Composite Blades After Whirligig Impact Testing, Tip View.

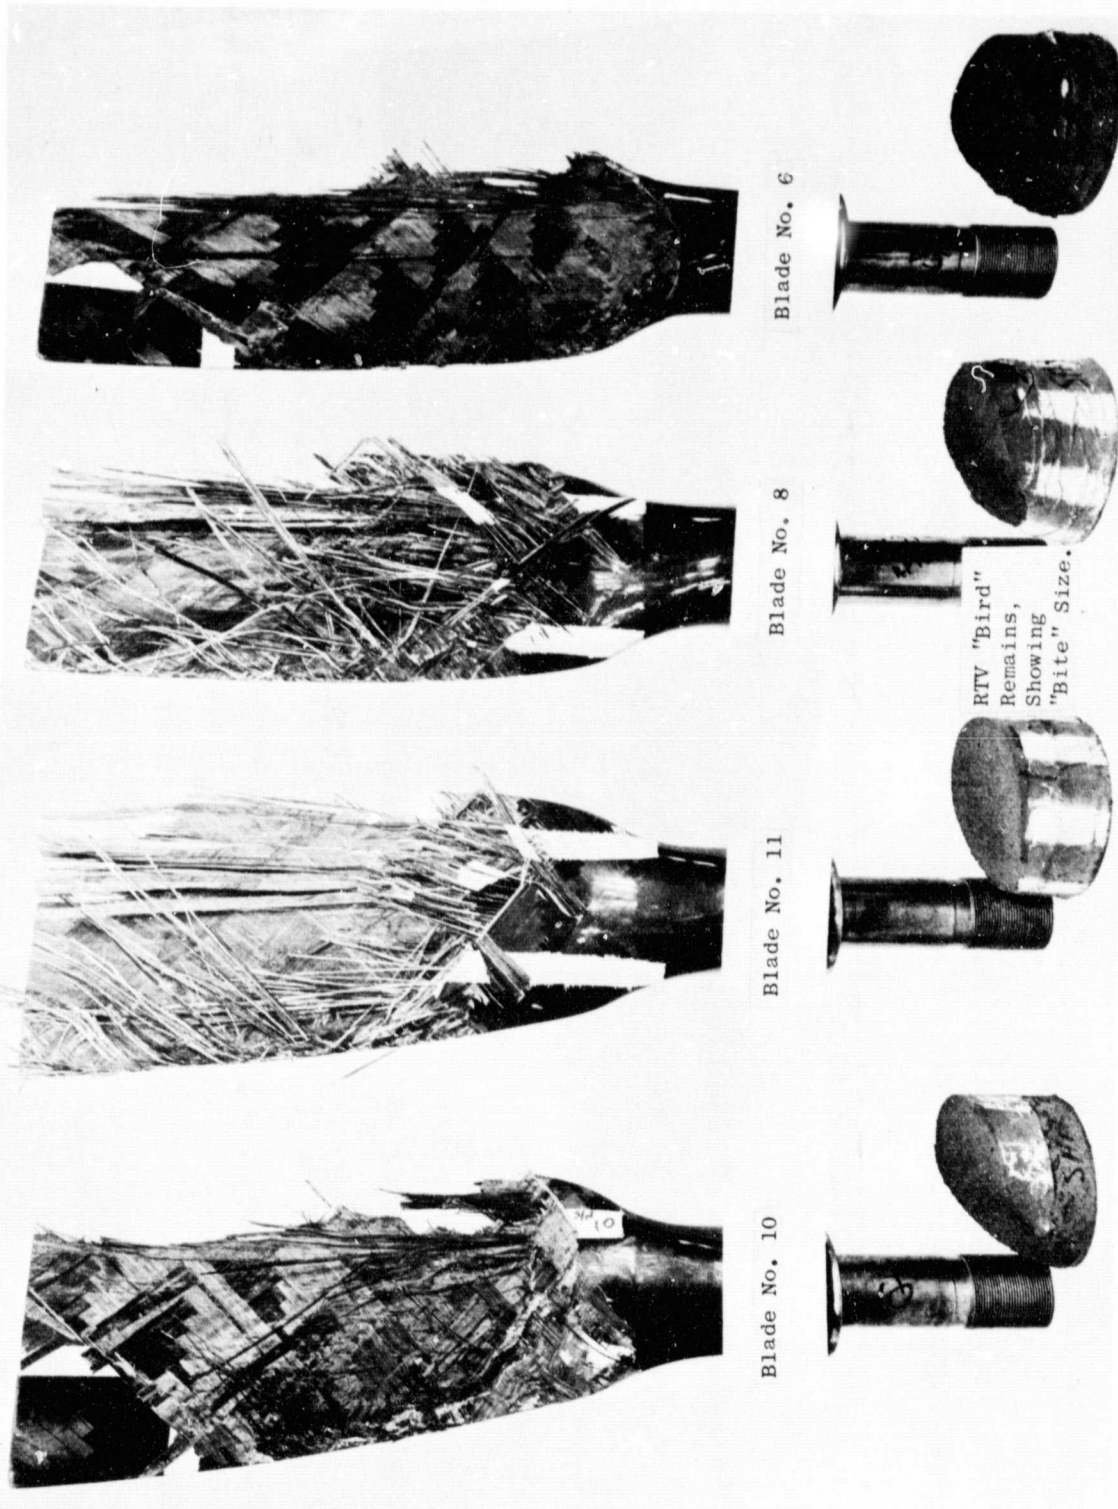
Figure 46. QCSEE Fiber-Wound Composite Blades After Whirligig Impact Testing, Front View.

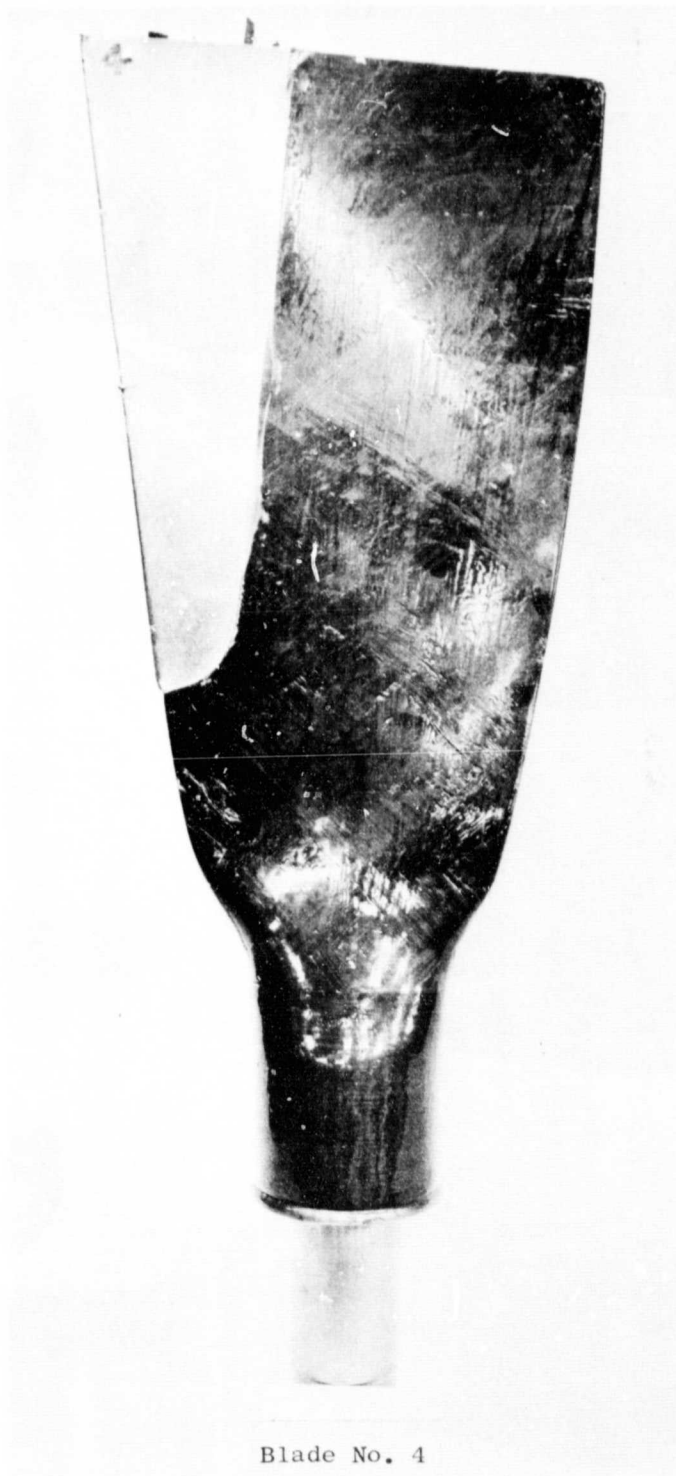
All tests, except that of blade S/N 4 (Test No. 6), which was tested with a starling at 23° incidence, resulted in the loss of the stainless steel leading edge and suffered severe breakage and delamination of the airfoil. Damage to blade S/N 4 for Test No. 6 consisted of bending of the stainless steel leading edge protection and delamination in the airfoil outer span but no weight loss. The results of the testing (including weight loss and extent of delamination) are summarized in Table 3. Photos of all blades after impact testing are presented in Appendix III. The results of ultrasonic and frequency inspections are discussed in Section 4.0.

Figure 47. QCSEE Fiber-Wound Composite Blade,
Concave View After Impact, S/N 4.

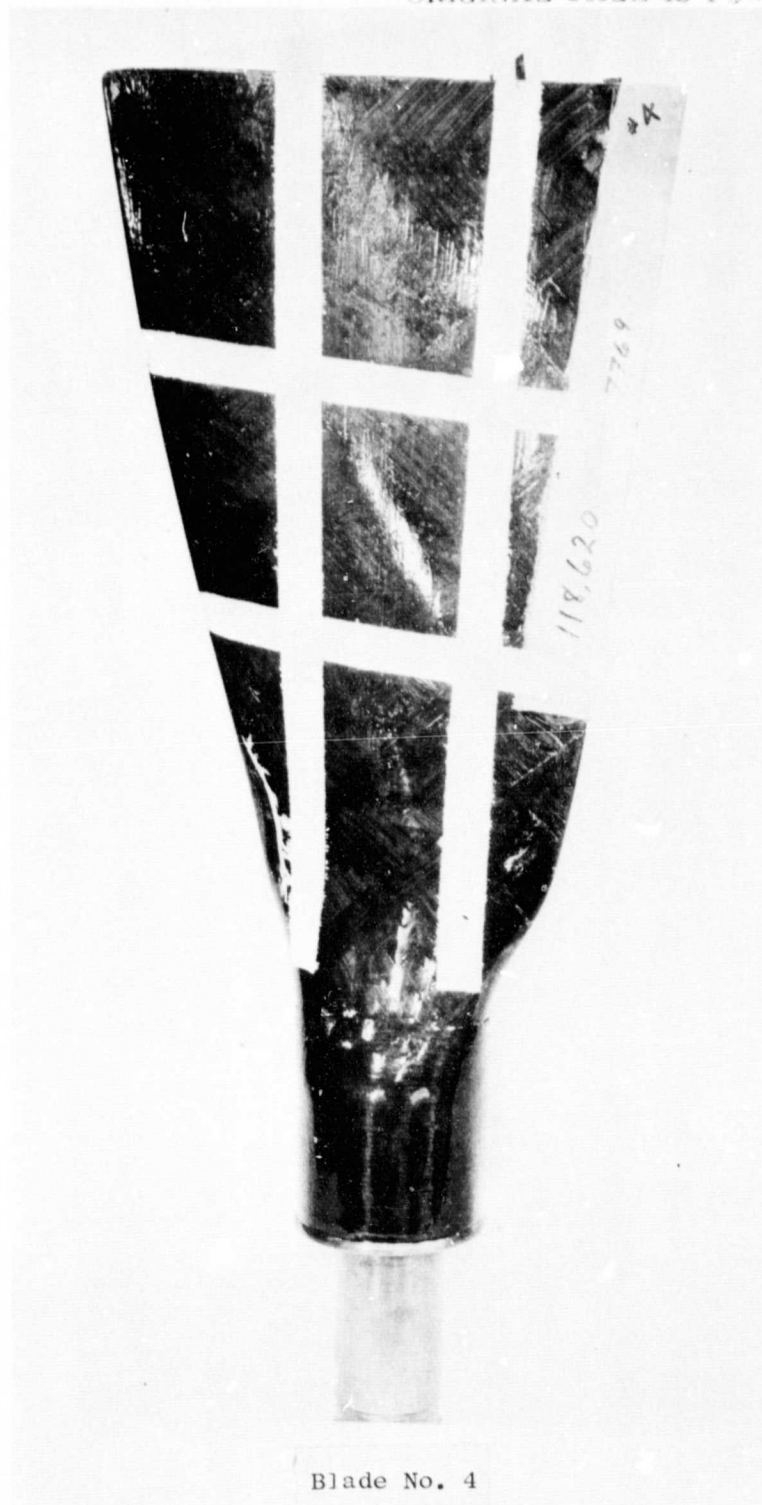
Figure 48. QCSEE Fiber-Wound Composite Blade,
Convex View After Impact, S/N 4.

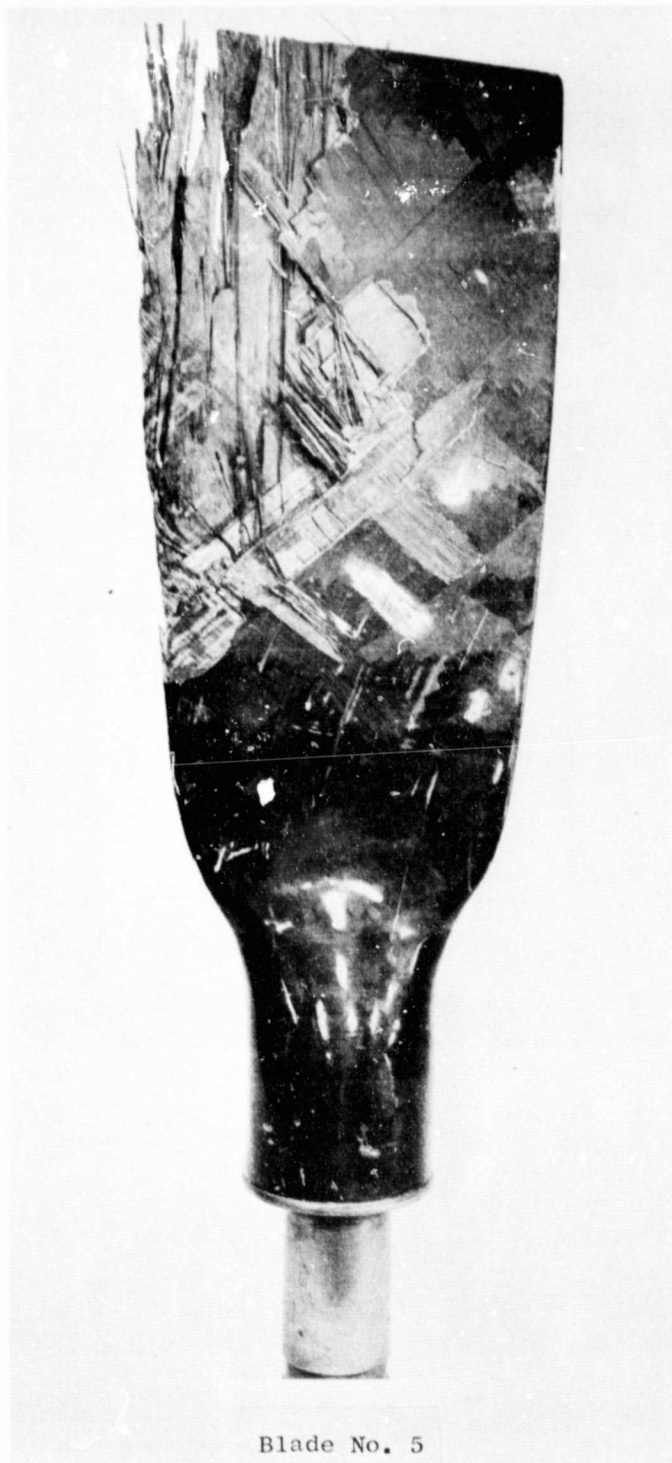
Figure 49. QCSEE Fiber-Wound Composite Blade,
Concave View After Impact, S/N 5.

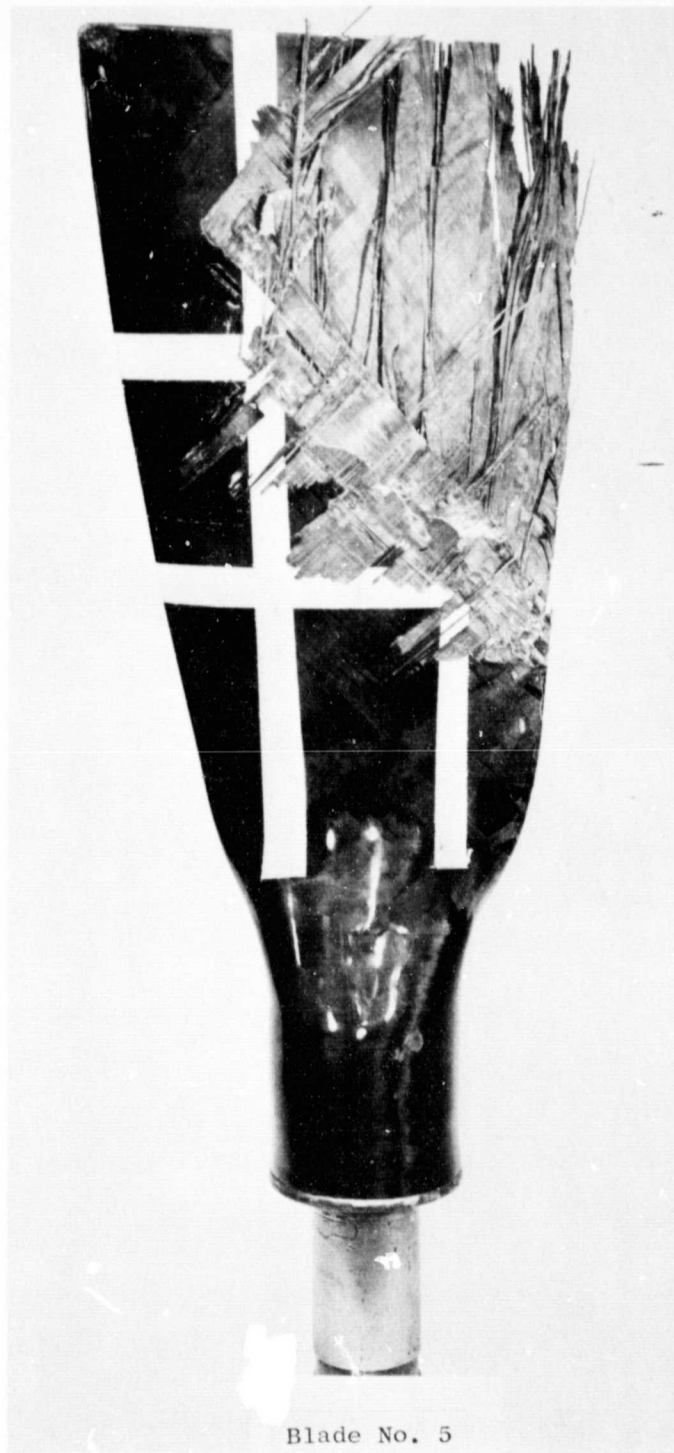
Blade No. 5

Figure 50. QCSEE Fiber-Wound Composite Blade,
Convex View After Impact, S/N 5.

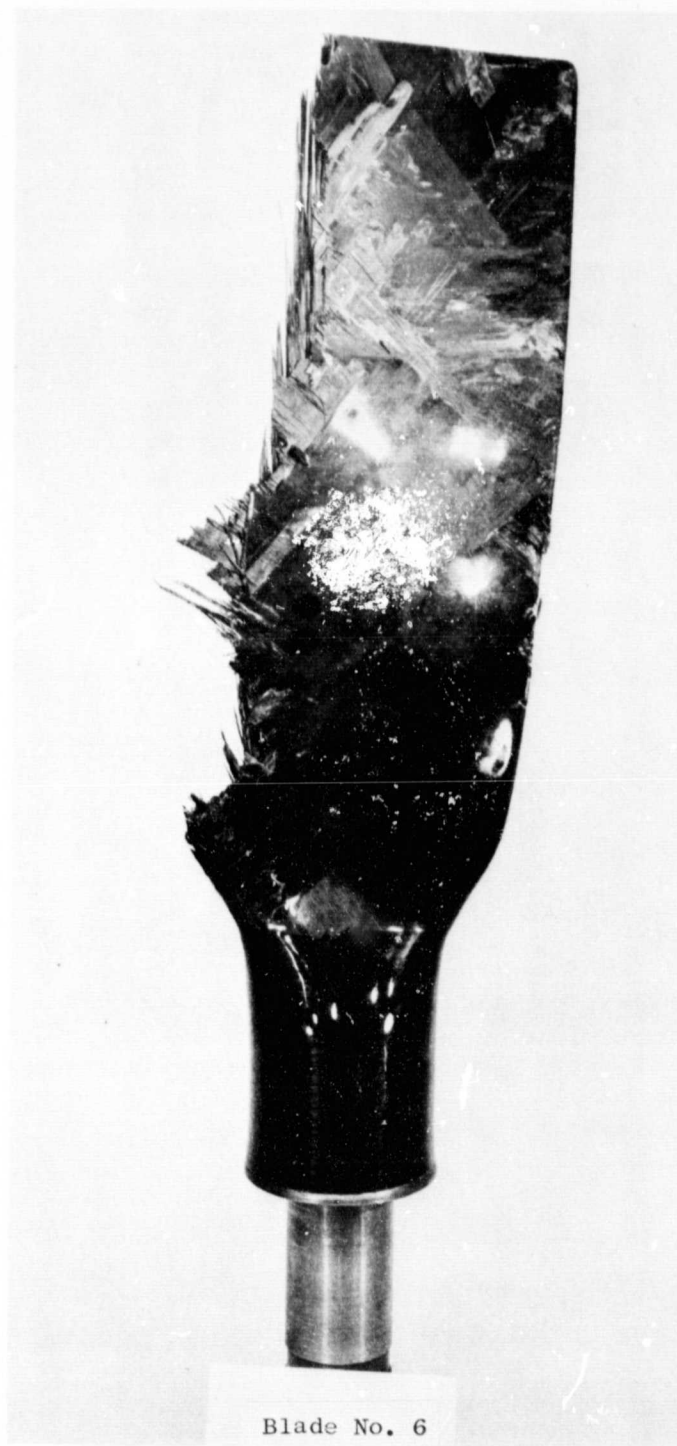
Figure 51. QCSEE Fiber-Wound Composite Blade,
Concave View After Impact, S/N 6.

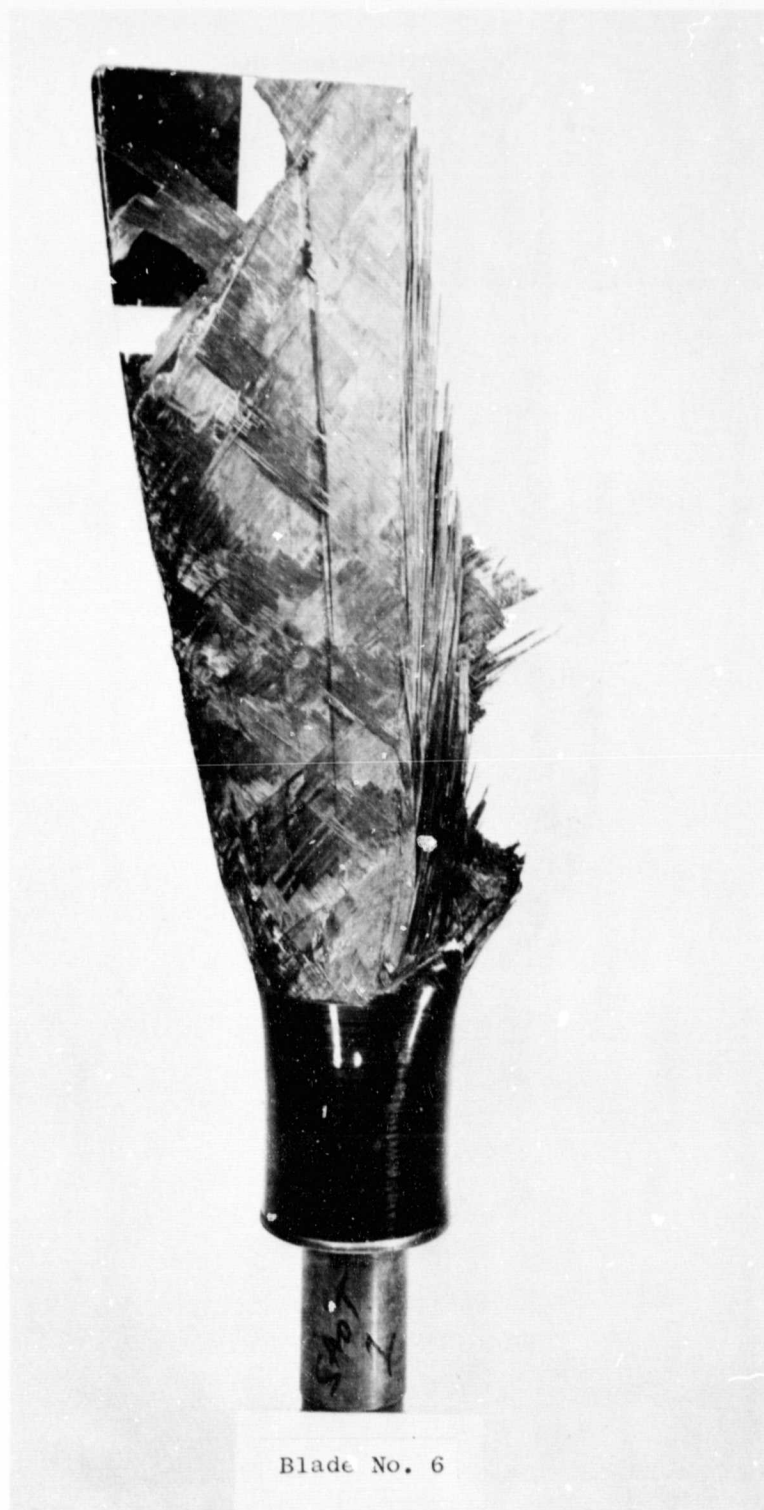
Figure 52. QCSEE Fiber-Wound Composite Blade,
Convex View After Impact, S/N 6.

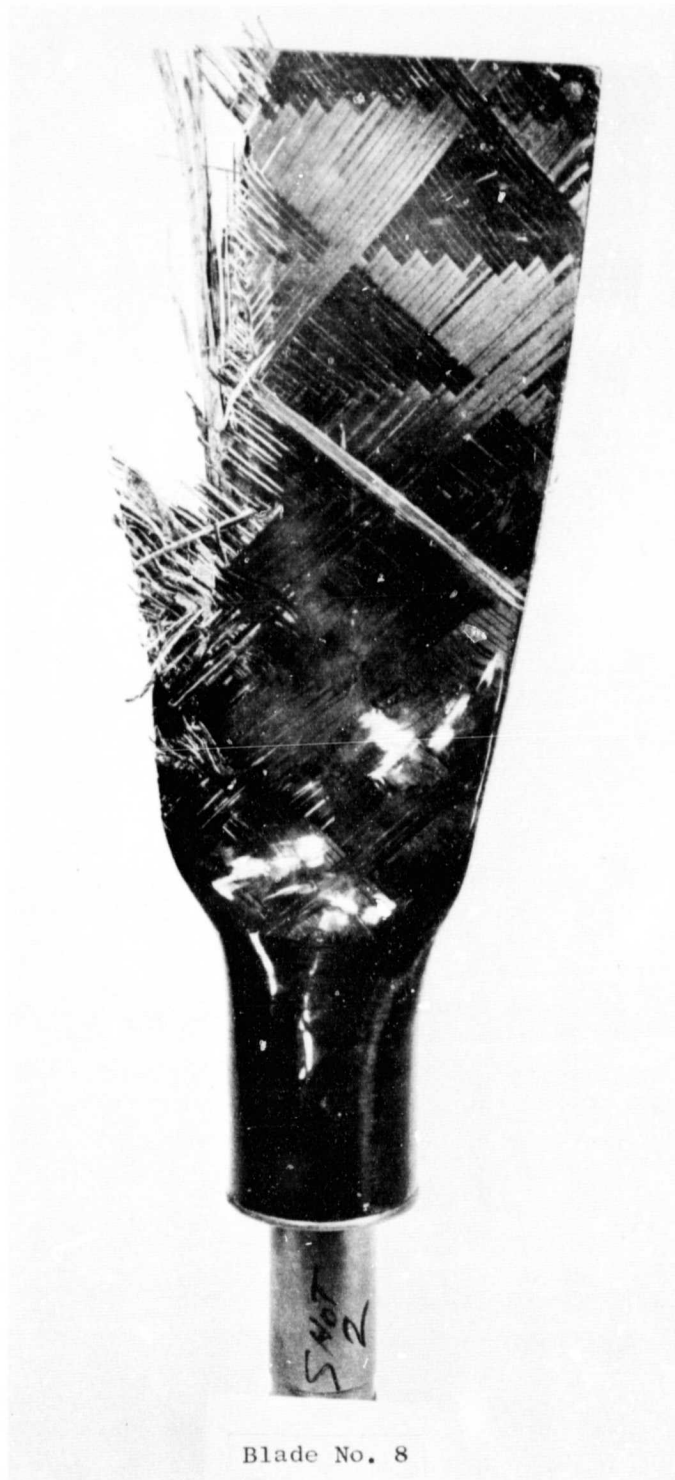
Figure 53. QCSEE Fiber-Wound Composite Blade,
Concave View After Impact, S/N 8.

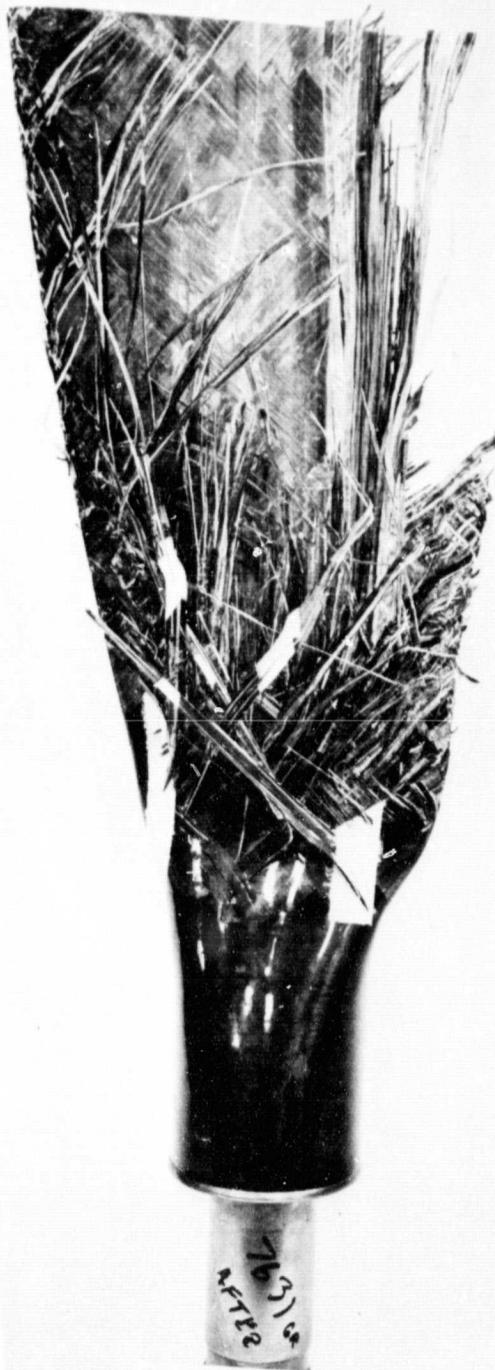
Blade No. 8

Figure 54. QCSEE Fiber-Wound Composite Blade,
Convex View After Impact, S/N 8.

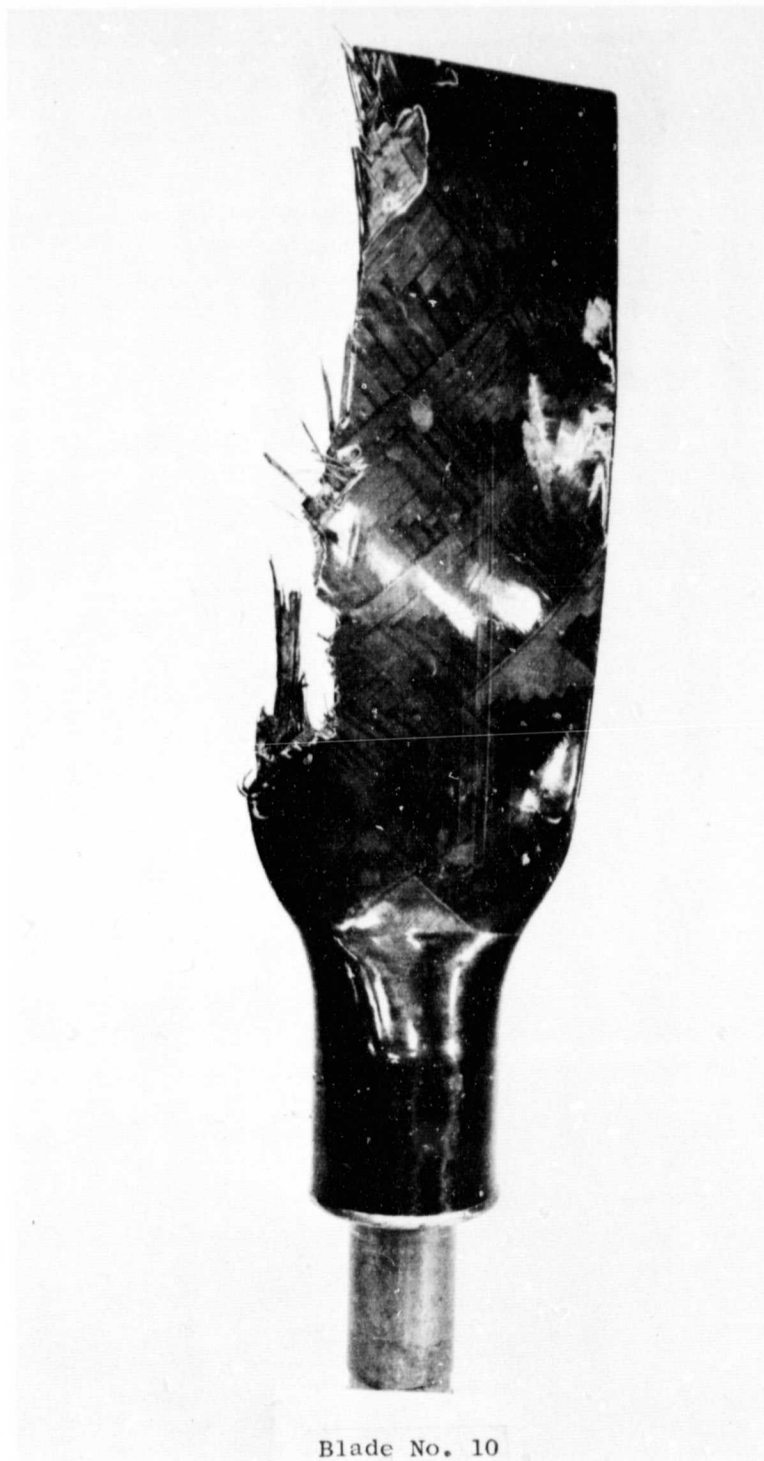
Figure 55. QCSEE Fiber-Wound Composite Blade,
Concave View After Impact, S/N 10.

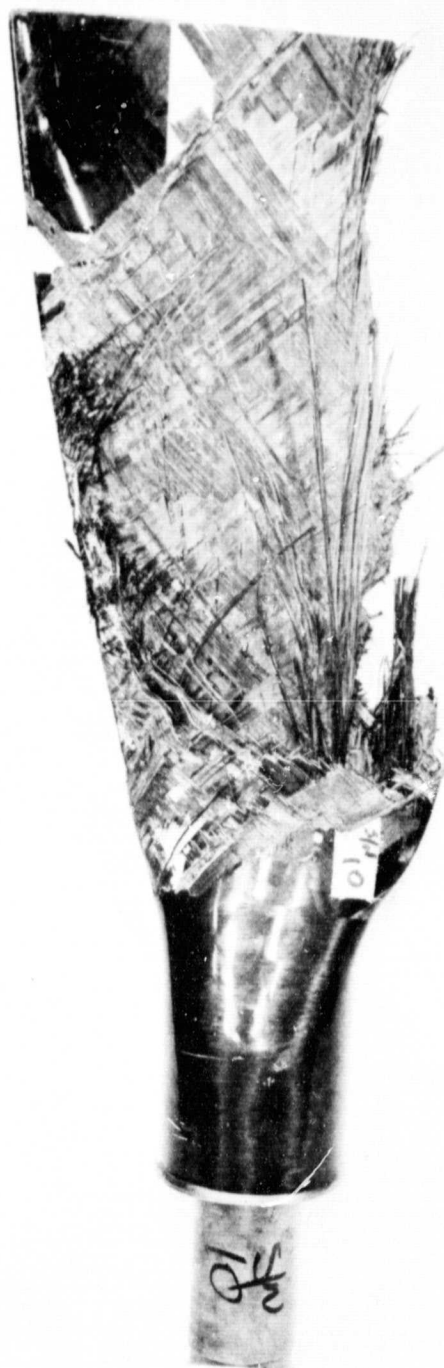
Blade No. 10

Figure 56. QCSEE Fiber-Wound Composite Blade,
Convex View After Impact, S/N 10.

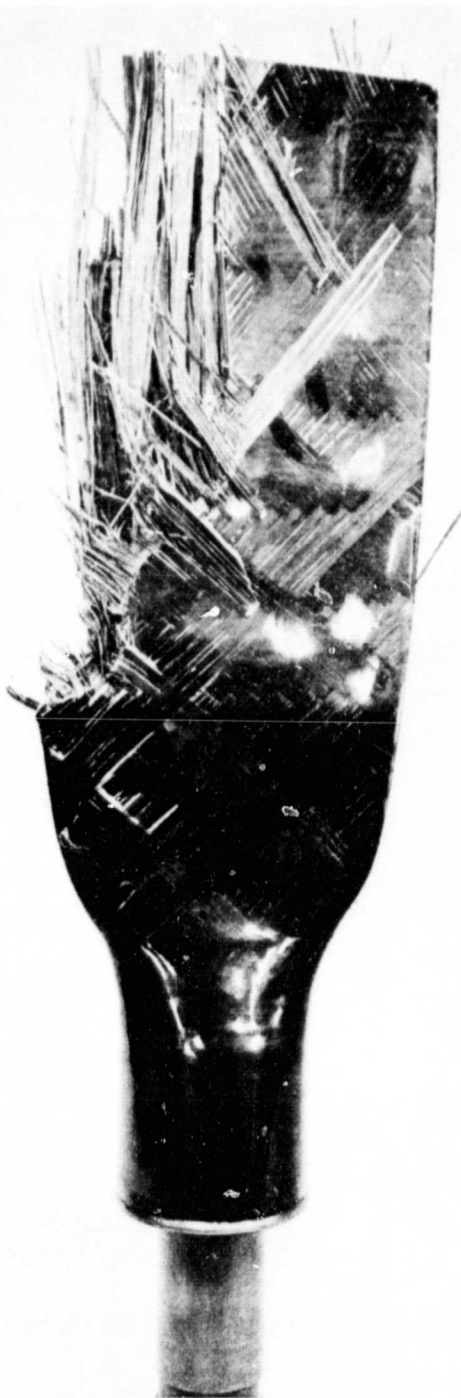
Blade No. 11

Figure 57. QCSEF Fiber-Wound Composite Blade,
Concave View After Impact, S/N 11.

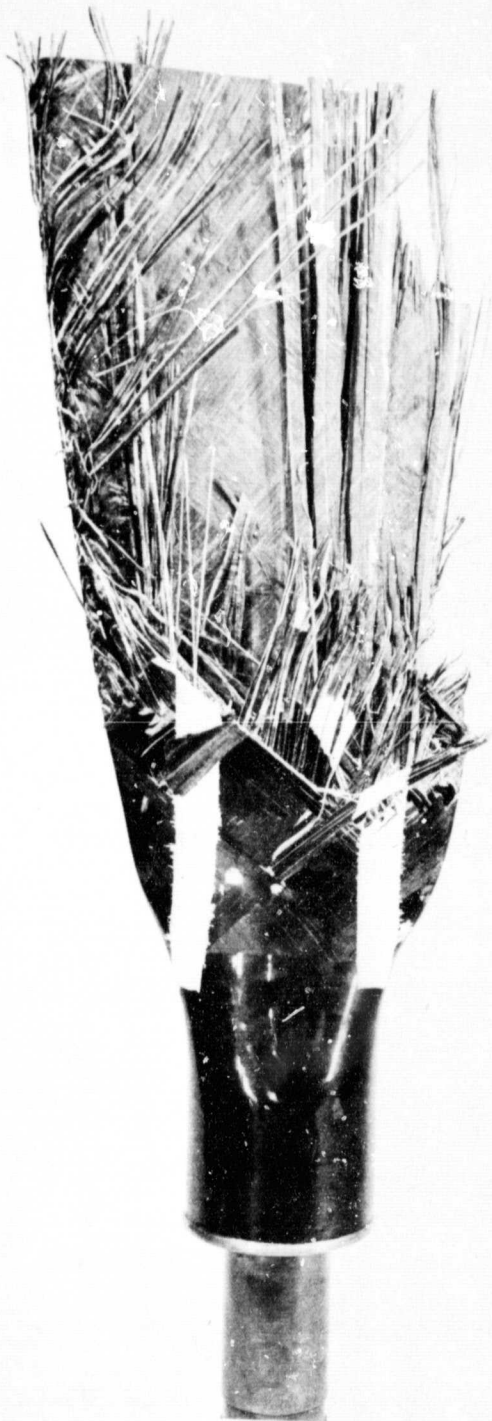
Blade No. 11

Figure 58. QCSEE Fiber-Wound Composite Blade,
Convex View After Impact, S/N 11.
